Manhole Inspection Summary

Manhole # S47E__041MH

Insp Date: **7/29/08 11:03 AM**

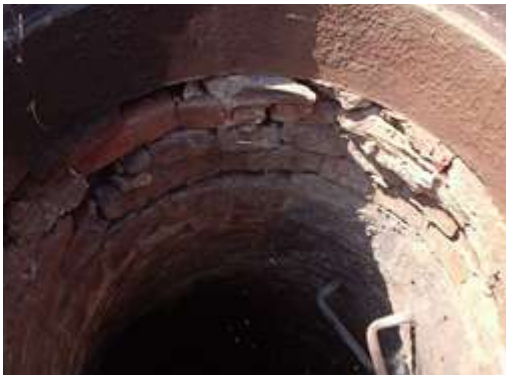
Defect 1

frame leaks

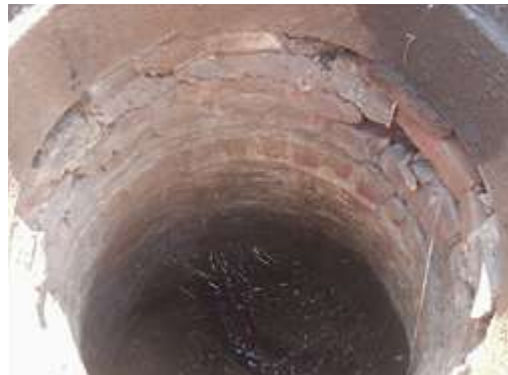
Defect 2

Condition: ☐ Sound ☐ Cracked ☐ Root Intrusion ☒ **Loose Brick** ☐ Deteriorated

Infiltration: ☐ None ☐ Joint ☐ Cracks ☒ **Mortar** ☐ Roots ☐ Wall

loose brick

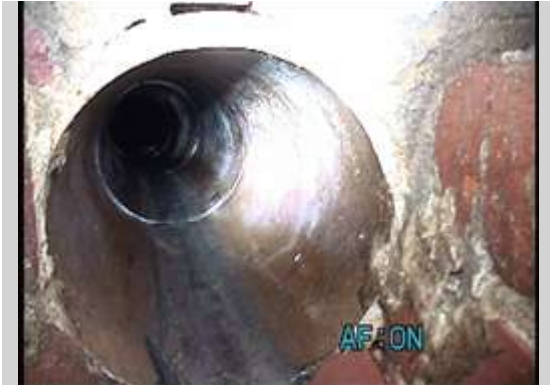
12 O'Clock Outflow

8 in. Circular Gravity Sewer
Pipe Out @ 12 O'Clock

Pipe Height: **8.4** (in.) Rod and Bar (Angled)
Pipe Material: **Clay** ☐ Pipe Lined
Invert Depth: **9.85** (ft.) Flow Characteristics: **Slow**
Deposits: ☒ None ☐ Mud ☐ Sludge ☐ Debris ☐ Grease
Silt Depth: (in.) Deposits Extent:
Infiltration: **None** Pipe Seal Cond: **Sound**

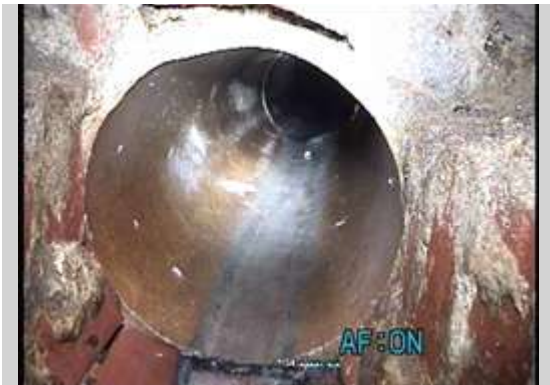
9 O'Clock Inflow

8 in. Circular Gravity Sewer
Pipe In @ 9 O'Clock

Pipe Height: **8.4** (in.) Rod and Bar (Angled)
Pipe Material: **Clay** ☐ Pipe Lined
Invert Depth: **9.55** (ft.) Flow Characteristics: **Slow**
Deposits: ☒ None ☐ Mud ☐ Sludge ☐ Debris ☐ Grease
Silt Depth: (in.) Deposits Extent:
Infiltration: **None** Pipe Seal Cond: **Sound**
